Intel® Celeron™ Processor Specification Update

Release Date: June 1999

Order Number: 243748-015

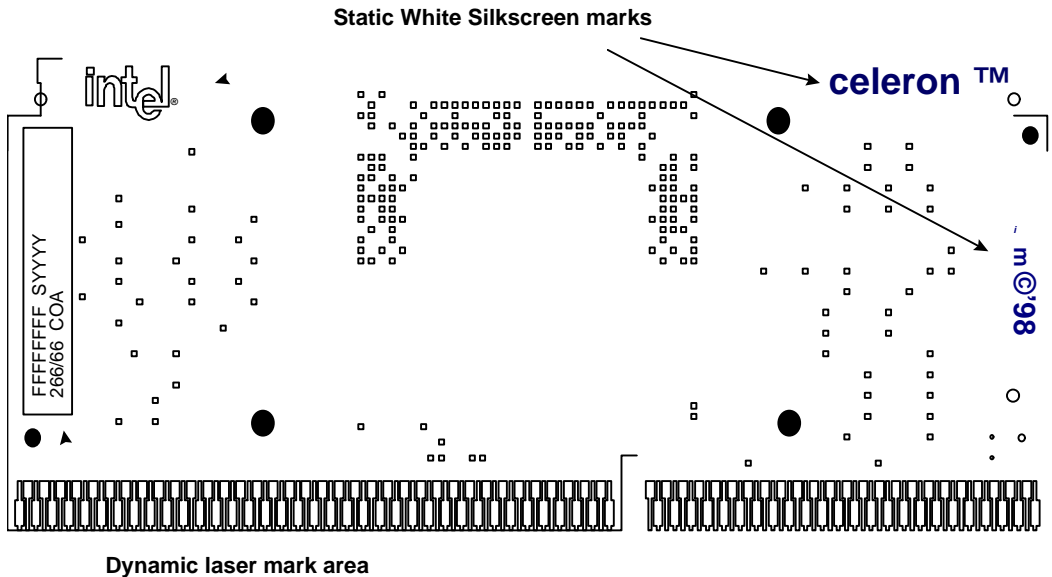
Intel® Celeron™ Processor and Boxed Intel® Celeron™ Processor Markings (S.E.P. Package)

- SYYY = S-spec Number.
- FFFFFFFF = FPO # (Test Lot Traceability #).
- COA = Country of Assembly.

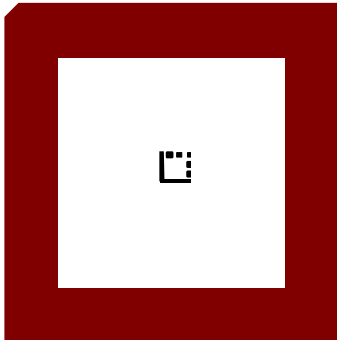
Top

Intel® Celeron™ Processor and Boxed Intel® Celeron™ Processor Markings (PPGA Package)

- AAAAAAA = Product Code
- ZZZ = Processor Speed (MHz)
- LLL = Integrated Level-Two Cache Size (in Kilobytes)
- SYYYY = S-Spec Number
- FFFFFFFF-XXXX = Assembly Lot Tracking Number
